Cientific Paper

Monitoring of water quality patterns in the Córrego Fundomicro basin, Ourinhos/SP and effects of the state plan of hydrographic micro basins

Study area

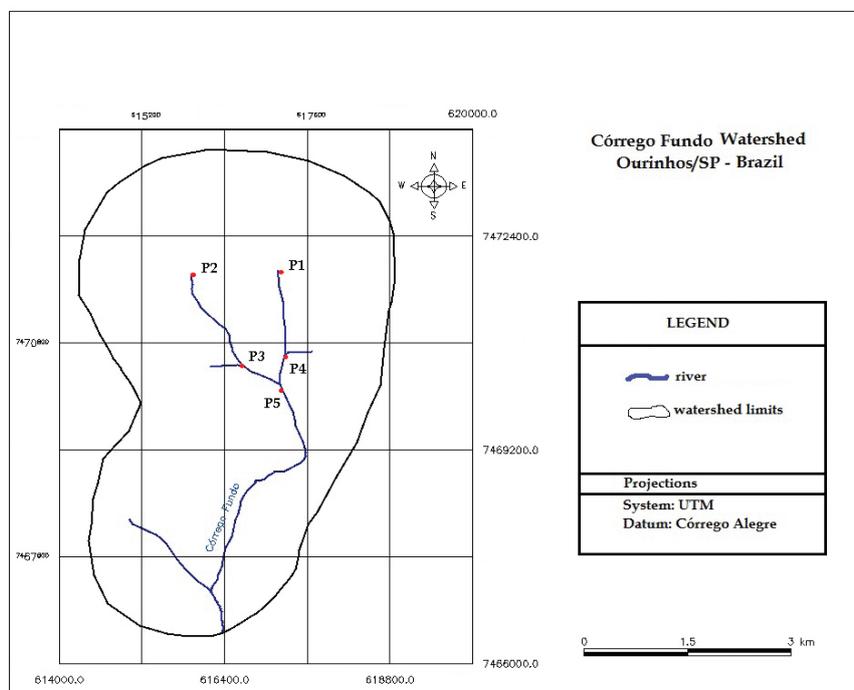
Figure 1. Schematic sketch of the Córrego Fundo Micro Basin, Ourinhos/SP.

The Córrego Fundo micro basin (Figure 1) is located in the rural area of the city of Ourinhos (SP) and is part of the Hydrographic Basin of the

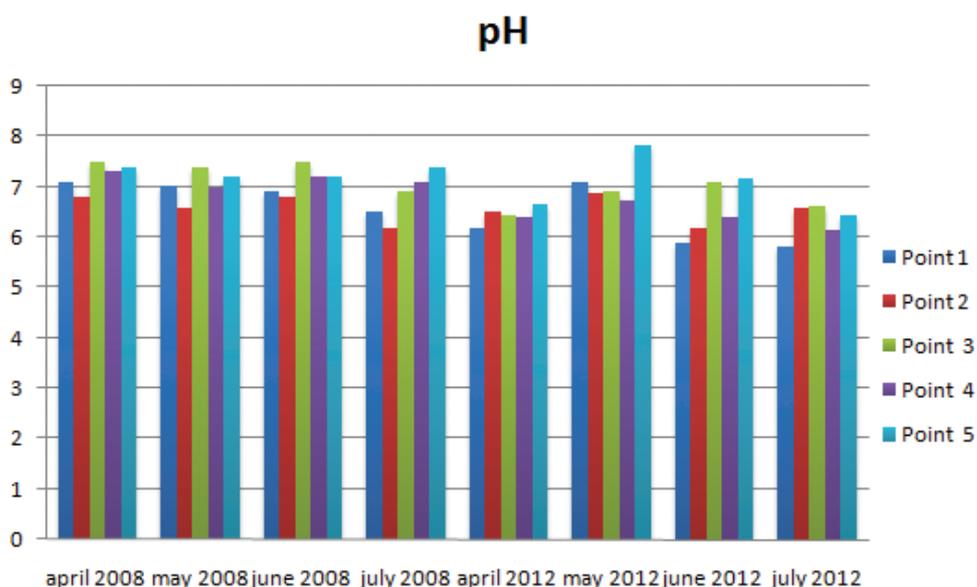
Figure 2. pH values of water in the Córrego Fundo micro basin in the period of April to July of 2008 and April to July of 2012.

The pH (Figure 2) varied little in seasonality function. The values of all points varied close to neutrality, whereas the lowest values are on P1 (river source 1) that reached 5.82 and the highest value was found on P5 (downstream) reaching 7.16. Although the values were close to neutrality, the ideal for aquatic life and human consumption varies from 6 to 9.5. Thus, the tendency is that the points present a slightly acid nature. There was no significant variance between the years of 2008 and 2012.

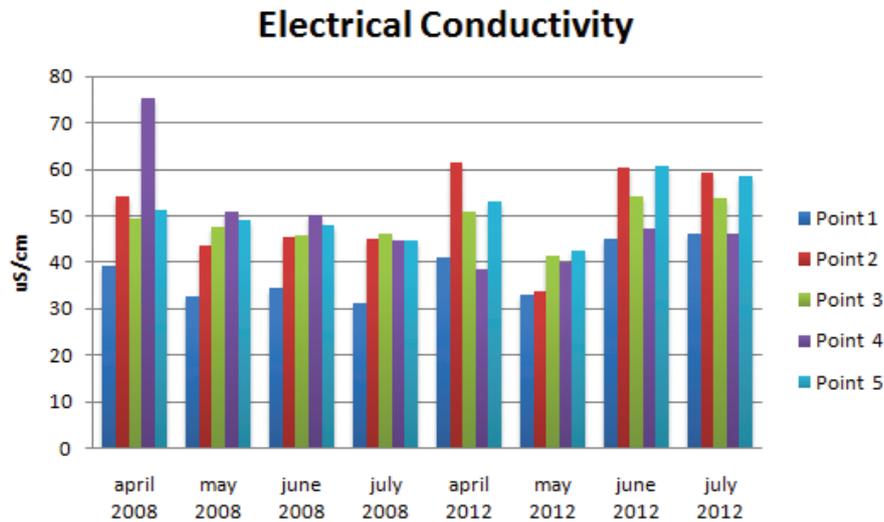
Figure 3. Electric conductivity of water in the Córrego Fundo micro basin in the period of April to July of 2008 and April to July of 2012.

For the electric conductivity (Figure 3) it was not established a parameter in the legislation, though in its highest concentration for being a indicative of salinity level or dissolved minerals in the water (EMBRAPA, 2011). The values increased gradually from 2008 to 2012 according to the observed (Figure 3). On P4 the electric conductivity presented a disparate value on April of 2008, but it was an isolated event, which may be associated with salt concentration in the water or even the dumping of some sort of substance on the river source. P2 (river source 2), P3 and P5 presented the highest levels in 2012. The hypothesis is that on those points there was a fertilizer entrainment into the stream, due to the planting of sugarcane and maize around the basin.

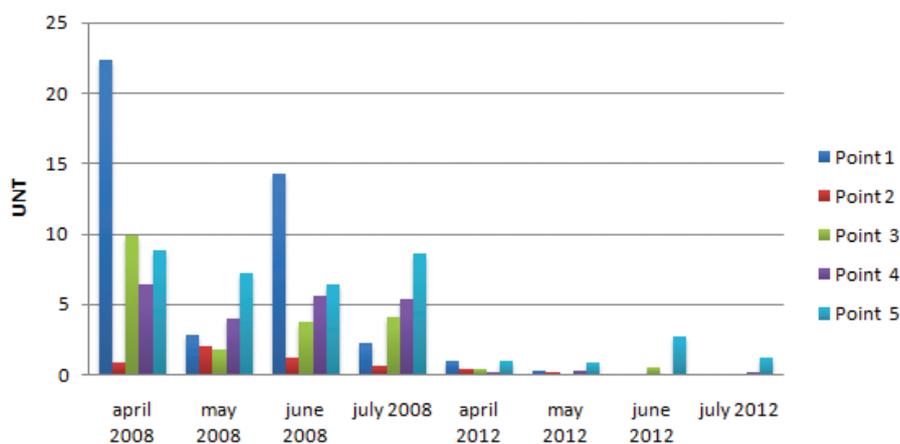
Figure 4. Water turbidity in the Córrego Fundo micro basin in the periods of April to July of 2008 and April to July of 2012.

The turbidity (Figure 4) presented a positive variation, from 2008 to 2012. Its values decreased gradually, presenting values very close to 0 UNT in the driest period. In rainy seasons the tendency of turbidity is to rise due to the leaching and particle transport from soil to the margins of water courses, though. According to what was found at field, the decrease of turbidity values may be associated with the recent reforestation conducted on Points 3 and 4 of the stream, where two artificial impoundments are formed. This may be an indicative that the

Since the acceptable values for human consumption, according to the actual legislation (CETESB, 2005), are up to 5 UNT and, for aquatic organisms, considering a river source of fresh water class 2, are up to 100 UNT, there are no major problems in the basin during the studied period.

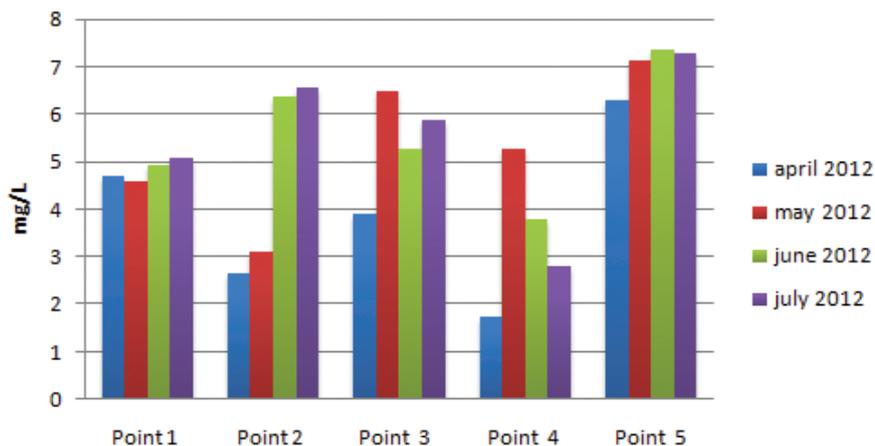
Figure 5. Dissolved oxygen in the water of Córrego Fundo micro basin in the period of April to July of 2012.

The dissolved oxygen (DO) was conducted as complementary analysis (Figure 5), since the studies of BATISTA (2008) did not contemplate this parameter. As seen on Figure 4, Points 2 (river source) and 4 (impoundment after source) presented an atypical variation of dissolved oxygen level. In cases of river sources, it is expected lower levels of oxygen, since the water was not in contact with the atmosphere. However, the differences between the values of the two river sources (P1 and P2) demonstrate that the reasons may be other. Another proposed hypothesis is that fertilizers used on the soil after being converted in substances such as the nitrate (NO_3^-) and transported to ponds and impoundments, changed mostly the quantity of dissolved oxygen, by the excessive growth of plants that will consume this oxygen, leading to degradation processes such as the eutrophication.

As for the atypical change of the dissolved oxygen patterns on P4 in relation to P1 (course source) denotes that the water body suffers alterations throughout its course (SILVA et al., 2012). The sugarcane crops on the surroundings of the impoundment, along with the lack of adequate practices of soil conservation and absence of exuberant riparian forest, following minimally the patterns established by the Forest Code - Law number 4771/65 (BRAZIL, 2012) contribute to the entrainment of fertilizers and sediments into the dam, favoring the growth of aquatic plants that consume the oxygen, causing the loss of water quality. The presence of macrophytes on the pond formed by the impoundment was verified in field. According to RESENDE (2002), in more extreme cases, the

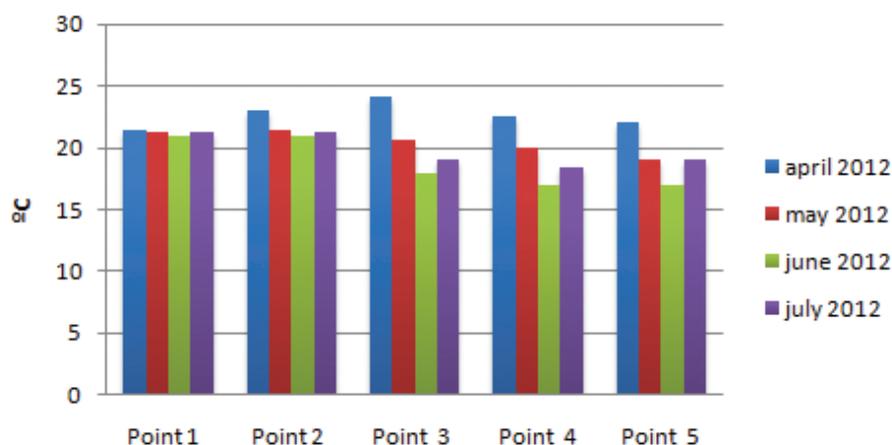
Figure 6. Water temperature in the Córrego Fundo micro basin in the period of April to July of 2012.

The temperature (Figure 6) did not exceed 25° C in all sampling points, the seasonality influenced in this point, since the studied period corresponded to autumn/winter, where the temperatures are milder. There is no maximum limit, in the legislation, for water temperature, but certain animal and vegetal species grow better in a specific range of temperature (between 25° to 30° C), other organisms such as bacteria, phytoplankton, as well as physical and chemical processes, may respond favorably to temperature increase. The rate of the majority of processes that affect water and soil quality doubles every 10° C on the temperature, the seasonality also may influence in this process (EMBRAPA, 2011).
