Geoprocessing tools to temporal analysis of size variation of the Paraná River islands in Sao Paulo, Mato Grosso do Sul and Paraná Border

Edson Luís Piroli, Raquel Marrafon Nicolosi, Vanessa Ramos dos Santos, Carlos Roberto de Melo

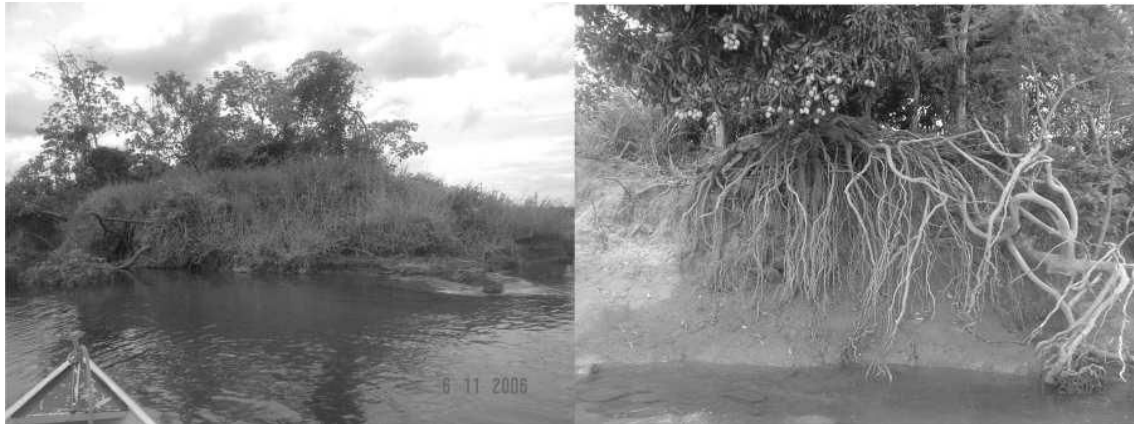
Figure 4. Photographs of the island 4 showing the impacts of erosion.

The island 4, to be also in the path of the water, had a significant decrease. Its size which in 1984 was 17.3 ha fell to 7.12 hectares in 2001. Figure 4 shows photos of the current margin of the island. Pay attention to the fallen trees in the picture from left and the mango tree root system completely exposed to the figure of the right.

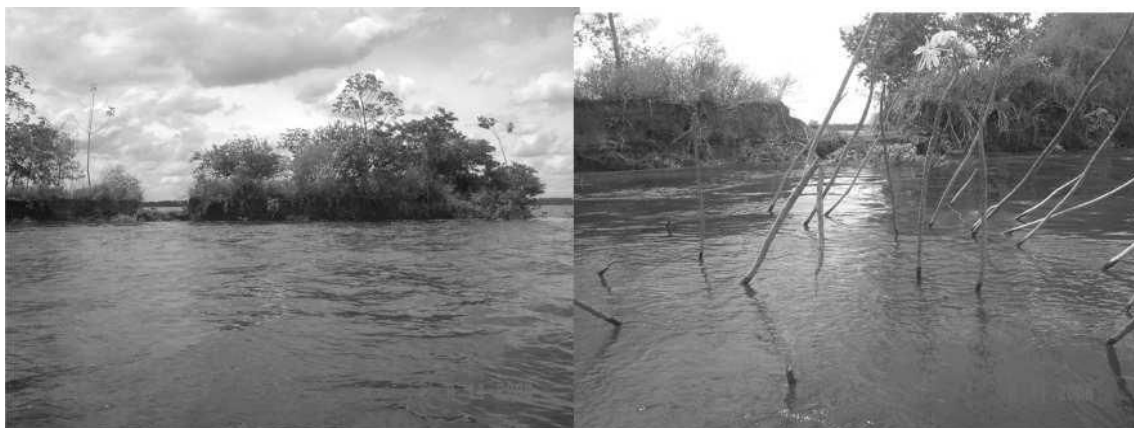
Figure 6. Process of corrosion of the island, in which blocks of land will be dropping. Here you can see that it is being split into two. In the photo on the right you will see an embaúba toppled by erosion.

On the River fountain side of the island 8 in 1984 there was a small island with an area of 2.94 ha that isn't visible in 2001. Moreover, on the River fountain side of the island, there was an intense process of corrosion, it happens until today, which has made the island diminish in size. In 1984 the area of the island was 147.8 ha and in 2001 it was reduced to 136 ha. Figure 6 shows the River fountain side of the island, highlighting the intense process of corrosion of its head.

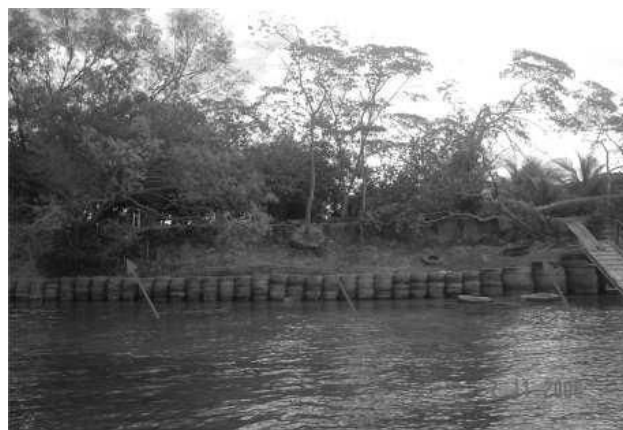
Figure 8. Protection of the island with tires. The arrows highlight the trees falling along with portions of the ground that support them.

The island 16 has remained with an area exceeding 420 ha in two images, which shows that the island size determines if the island has a lower risk of losing ground with the current. This fact can also be explained by the presence of larger size vegetation in these areas, which gives greater resistance from the ground supported by the roots the action of water. However, as you can see in figure 8, it is currently suffering with the process of intensified erosion. It should also be noted that this figure the owner of the island portion on the River fountain side is trying to protect it from erosion by the use of tires.

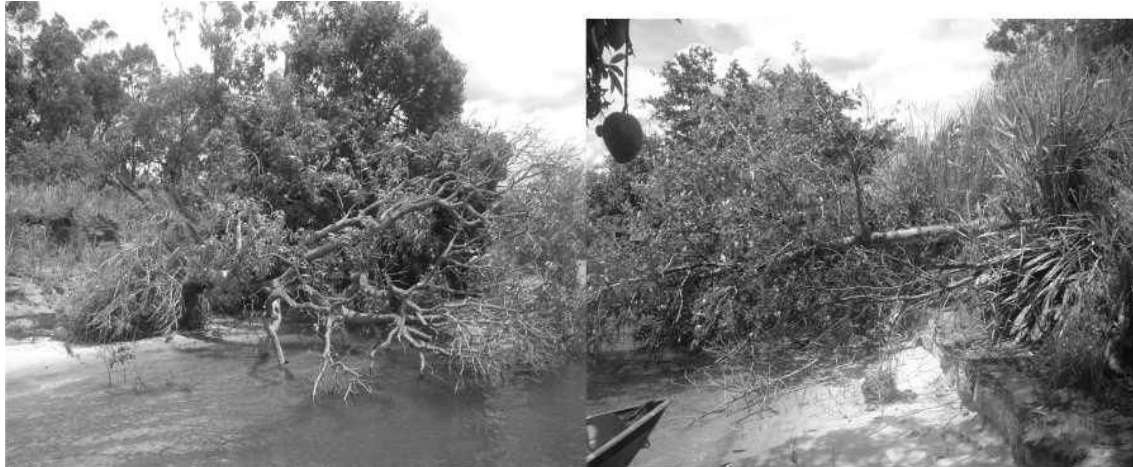
Figure 10. Adult mango tree on the left and adult jack fruit tree on right fell down because force of water from the Parana River in its constant fluctuations.
